# Manhole Inspection Summary

Manhole # S11Y\_\_016MH

Insp Date: **4/7/08 10:16 AM**

**Location** Address: **1201 Bloomfield Ave**

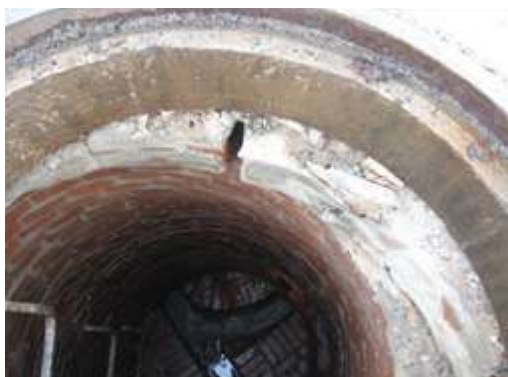
Defect 2

Offset: **4** (in.)

frame offset 4 inches

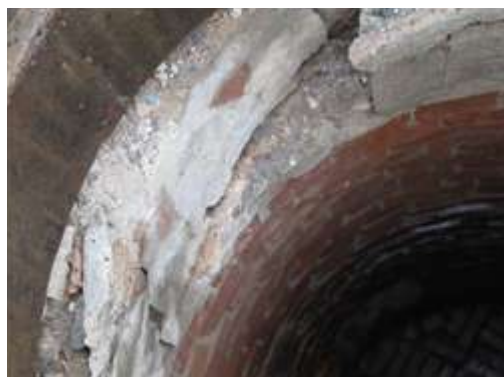
Defect 2

Condition: ☐ Sound ☐ Cracked ☐ Root Intrusion ☒ **Loose Brick** ☐ Deteriorated

Infiltration: ☐ None ☐ Joint ☐ Cracks ☐ Mortar ☐ Roots ☒ **Wall**

chimney loose bricks and infiltration at wall

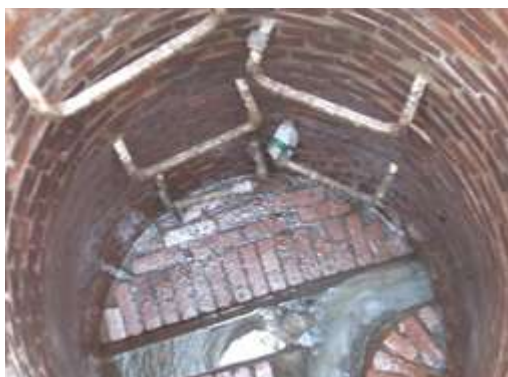
Defect 3

Count: **5** Missing: **0** ☒ **Corroded**

steps corroded

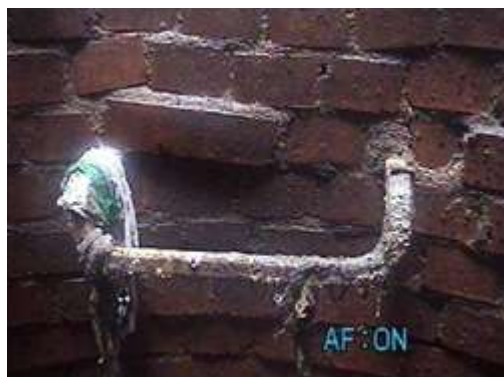
Defect

☒ **Evidence Of Surcharge** Depth: **3** (ft.) ☐ Active Surcharge Present

surcharge evidence 3 feet

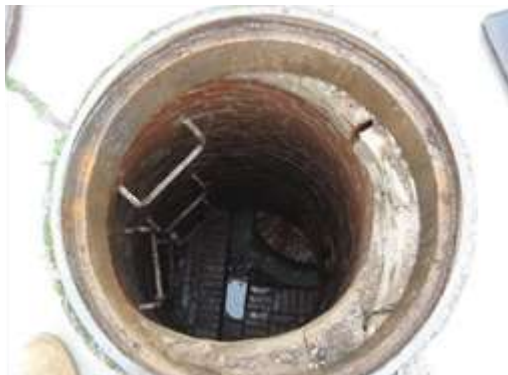
### Defect 1

☒ **Leaks**

frame leaks at cover
